SATOFSHFS3

Floor-standing Rimless Toilet

INSTALLATION INSTRUCTIONS

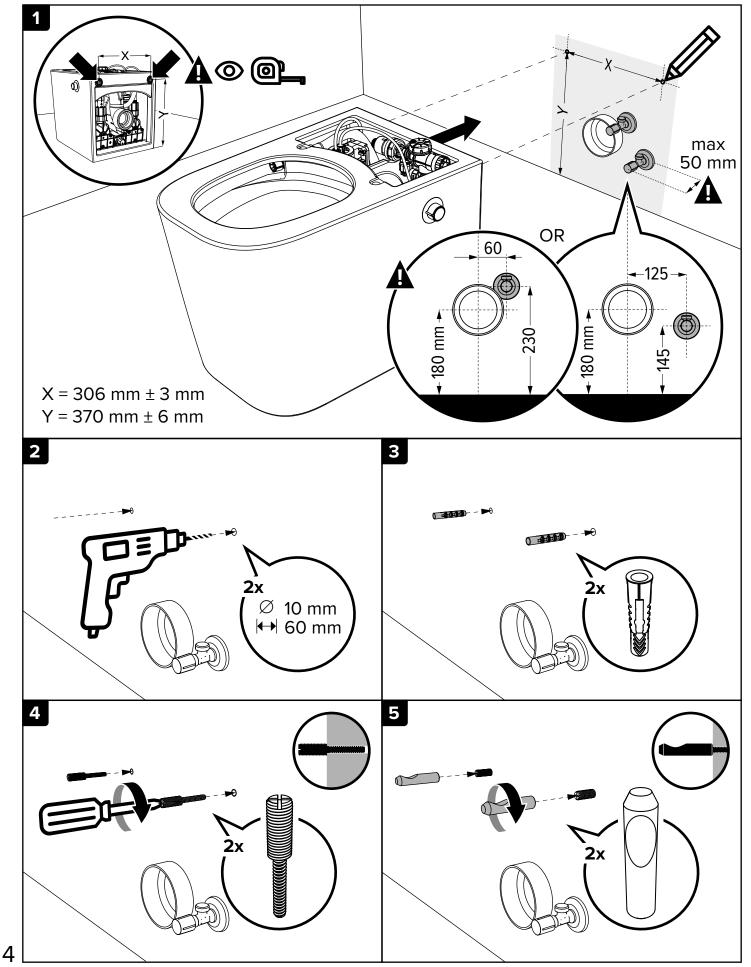
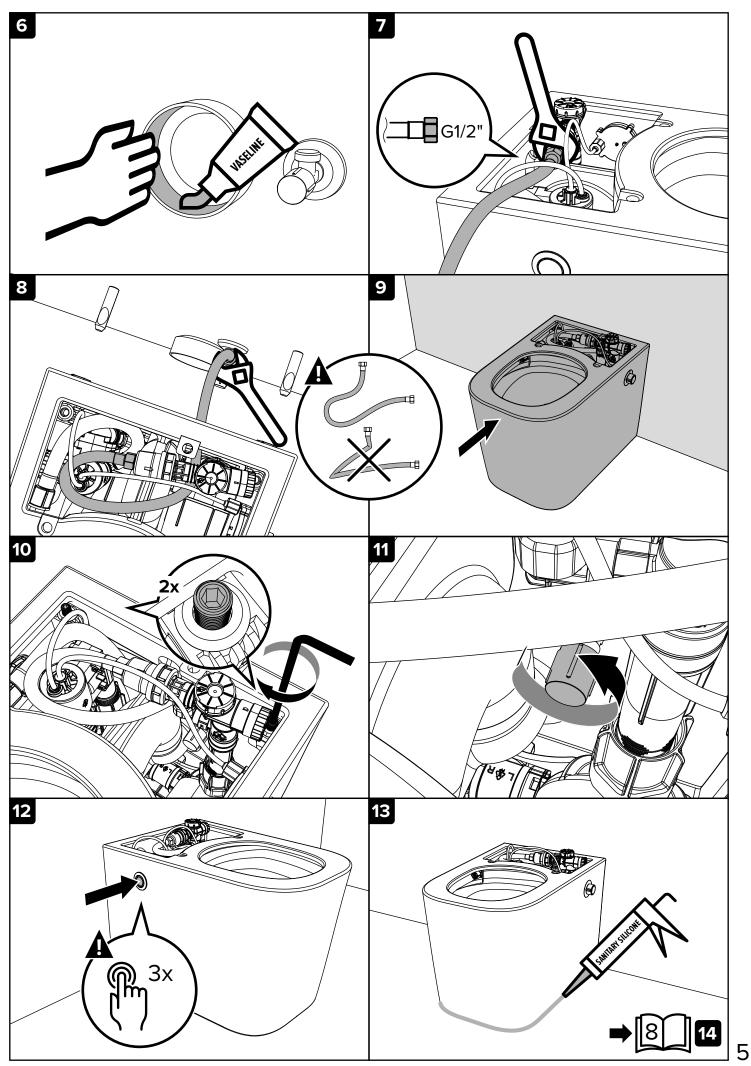
TOILET INSTALLATION

NOTE: Mounting surface must be clean and level before toilet is installed! To avoid installation issue, please locate the wall mounting holes with the real ceramic hole, so they will be align with each other when lock.

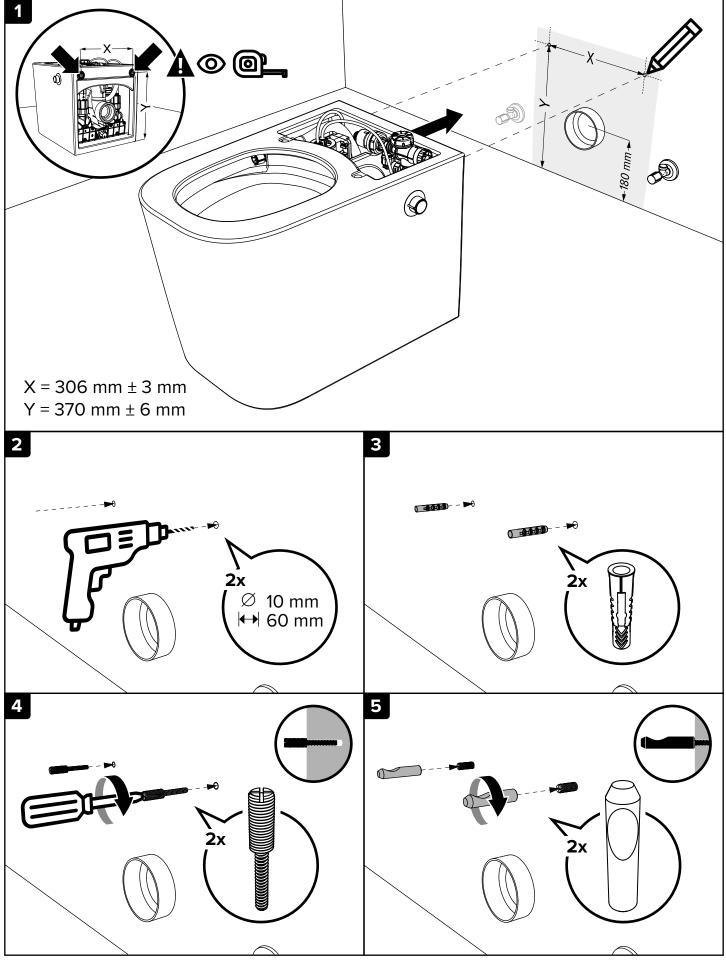
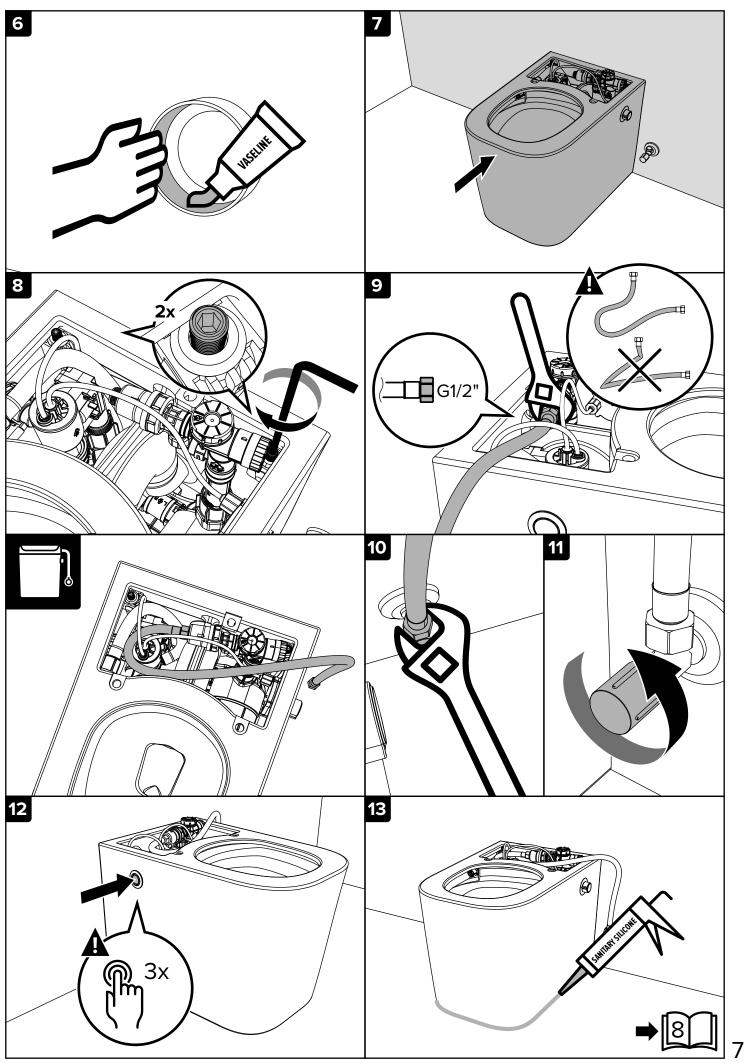
TOILET INSTALLATION

NOTE: Mounting surface must be clean and level before toilet is installed! To avoid installation issue, please locate the wall mounting holes with the real ceramic hole, so they will be align with each other when lock.

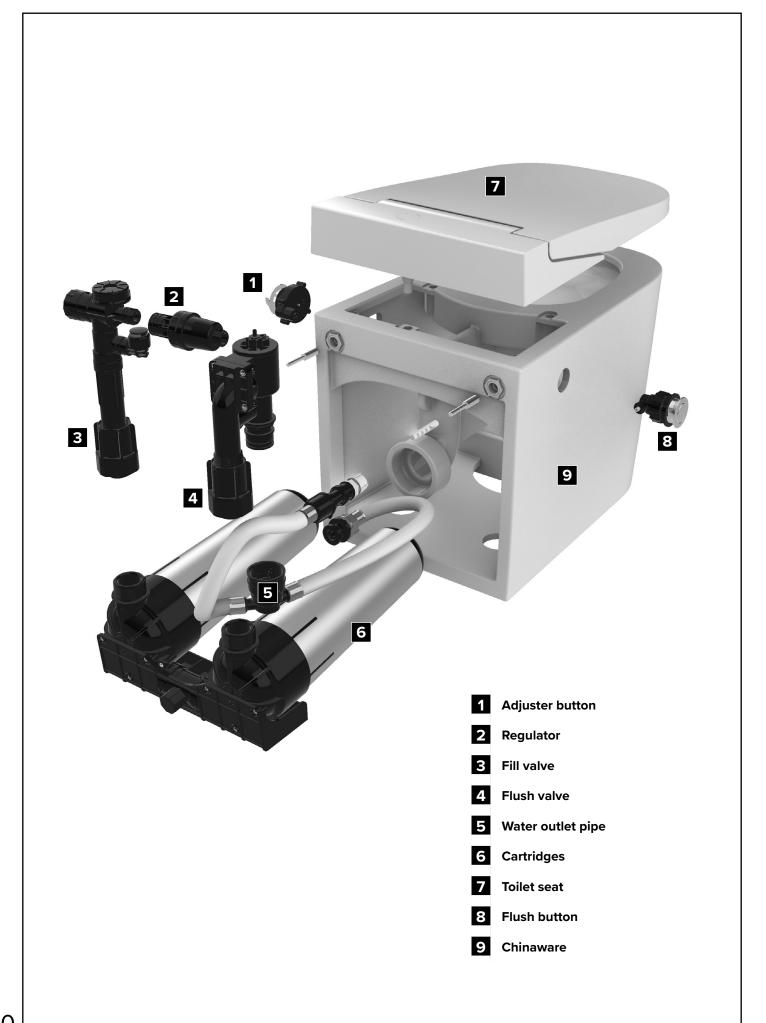
REPAIR PARTS LIST

No		Part Name	Part Number	Usage
1		Adjuster button	NDSATOFSHFS2AB	1
2		Regulator	999910060150	1
3	1	Fill valve	112070031020	1
4		Flush valve deck & core	112070031023 NDSATOFSHFS2FV	1
5		Water outlet pipe	NDSATOFSHFS2OP	1
6		Cartridges	NDSATOFSHFS2CA	1
7		Toilet seat	NDSATOFSHFS2SE	1
8		Hydraulic flush button	112070031021	1
9		Chinaware - ceramic toilet	NDSATOFSHFS2WC	1
