## Test report No.:

# 184000083

**Test name:** Test of hydraulic properties

**Subject of testing:** IPS Kalyxx RedLine

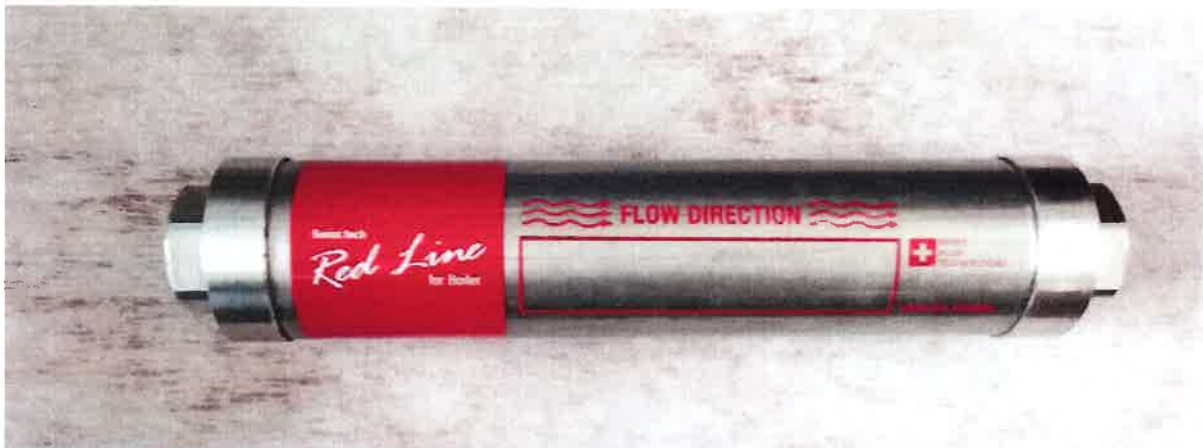
Picture 1 IPS RedLine

- Connection type: G1/2" (on both sides)
- 5. Sample description:**
- The device is designed for the physical treatment of water. Prevents formation of limescale and corrosion. It also helps to remove them. IPS can be installed in closed and open dynamic systems.

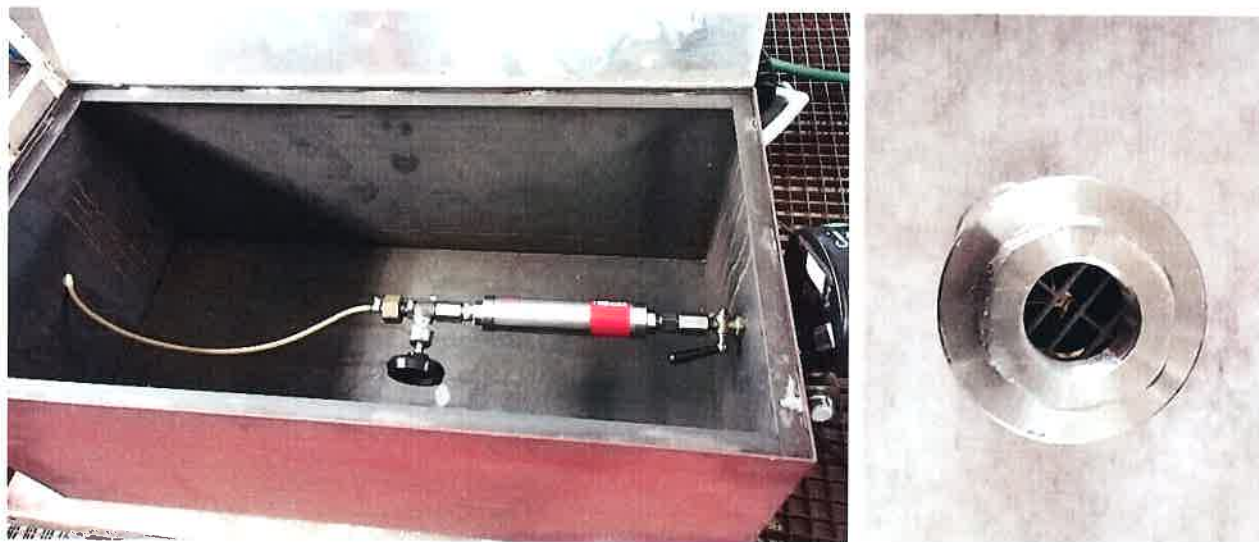
Picture 2 IPS RedLine in the test cabinet and during distance measurement.

The target of strength test was verifying that the product is capable to resist pressure of 1, 5 and 10 MPa. Another requirement was to measure (before and after the test) the distance between the inner component (propeller) and the inlet and determine if there is deformation effects during the test.

The product was clamped in the test cabinet and subsequently exposed to the required pressure.

During the test, the product showed no signs of damage and no leakage was detected. The distance between the center of the first component and the input section remained unchanged – 27,7 mm.
